Honeyfield Fountain, New Plymouth

# CONDITION AND REMEDIAL ACTION REPORT

*Ian Bowman, Architect and conservator*  
2003

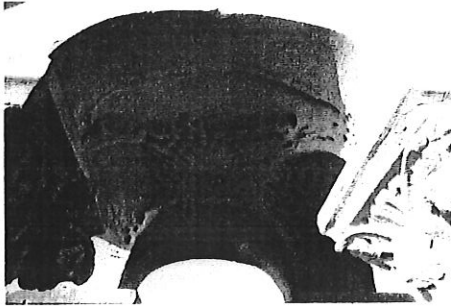
**1 interior showing alveolisation**

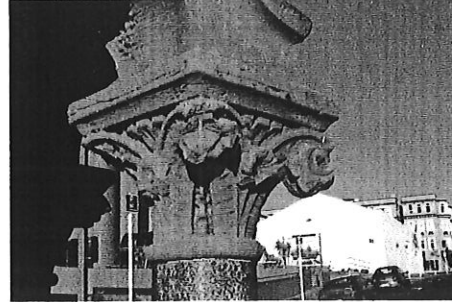
**2 SW capitals showing volute damage and alveolisation**

Reinstate damaged or missing decorative stone elements such as missing volute ends

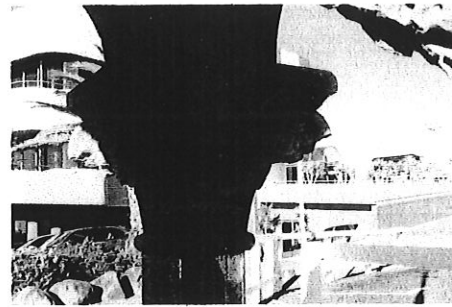
**4 SE capitals showing volute damage and alveolisation**

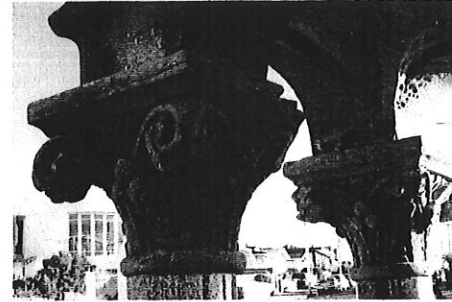
**6 NW and NE capitals showing volute damage and alveolisation**

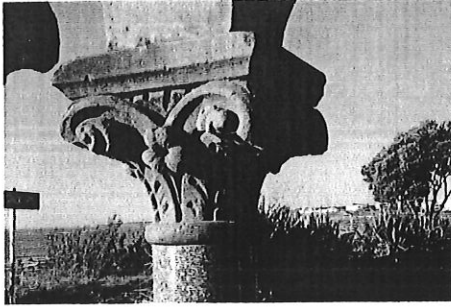
**7 NE capitals showing alveolisation cracking and volute damage**

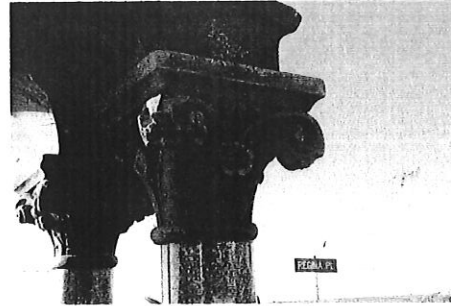
**8 NE and SE capitals showing volute damage and alveolisation**

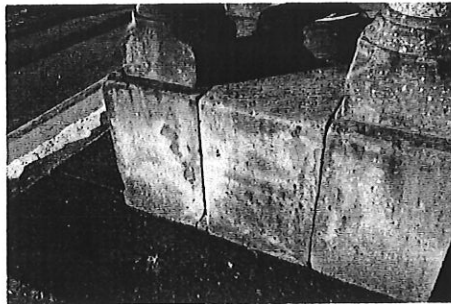
**9 West showing plastic repair, pitting and skin damage to base**

Carefully remove all cement mortar and cement plastic repair,

Repoint and repair in lime based mortar;

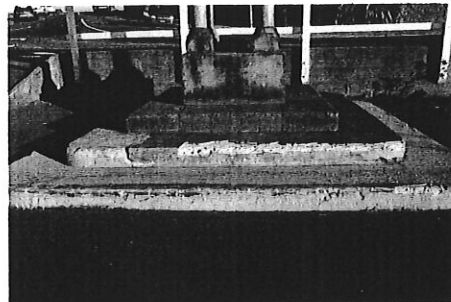
Chlorides are very damaging to reinforcing steel as oxidation can continue without the presence of moisture. It is likely that rusting of steelwork has caused the fracturing visible on the external cement surfaces.

**11 Damage to cement base**

Remove crazed render on concrete steps and rerender

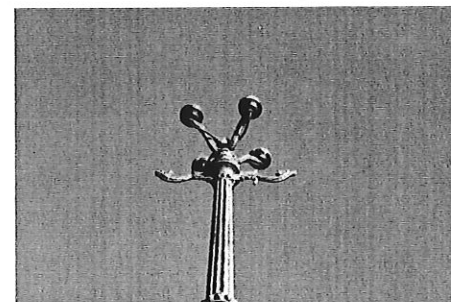
**12 Lamp standard showing rust and paint damage**

Clean down and recoat cast iron, treating for rust with appropriate marine environment resistant paint systems

Reinstate missing lights and decorative elements based on accurate documentation
