Archaeological Resource Management

Small's Cottage

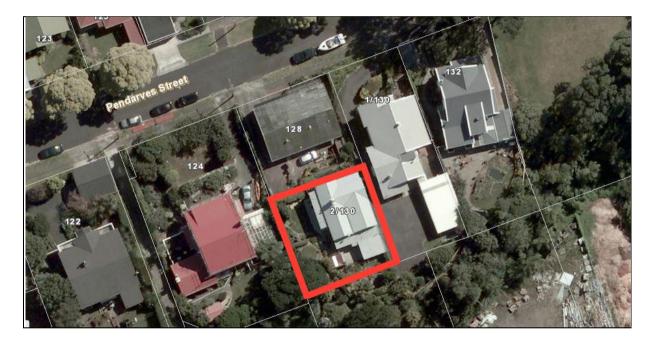
Figure 1: Location of Small's Cottage, 130 Pendarves St, New Plymouth outlined in red.

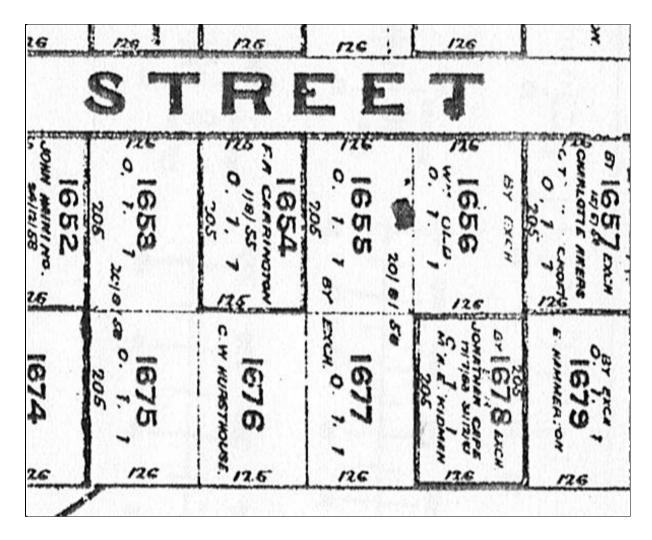
Figure 2. Crown grant map, showing section 1657 owned by Charlotte Akkers. No buildings are noted on this property on this plan.

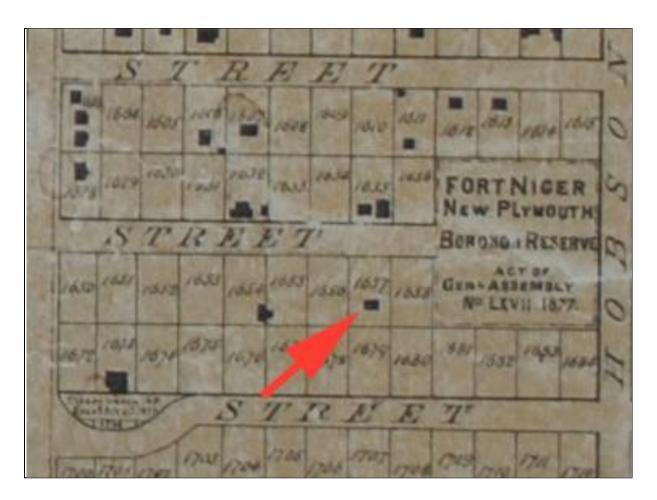
Figure 3: Extract from Plan of the Town of New Plymouth 1880, by T.K Skinner, showing the recently constructed Small's Cottage on Section 1657.

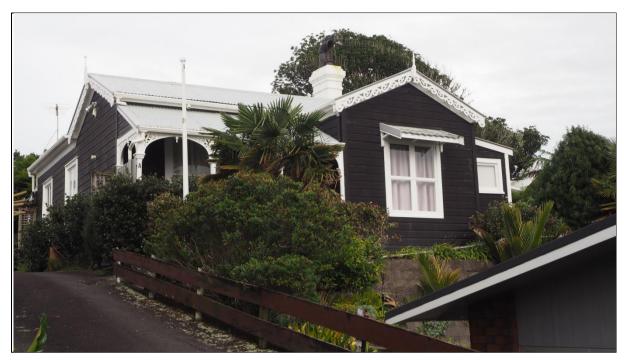
Figure 7: Photograph of the northern elevation. Veranda, veranda bedroom window, decorative barge boards and rusticated weatherboard cladding are all original. The front door and widow are later replacements. The western extension, seen to the right of the front window dates from 1986. Image: Ivan Bruce, 2017.

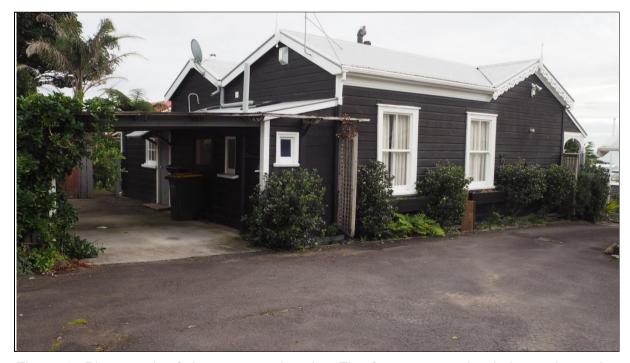
Figure 8: Photograph of the eastern elevation The four pane sash windows, decorative barge boards and rusticated weatherboard cladding are all original Image: Ivan Bruce, 2017.

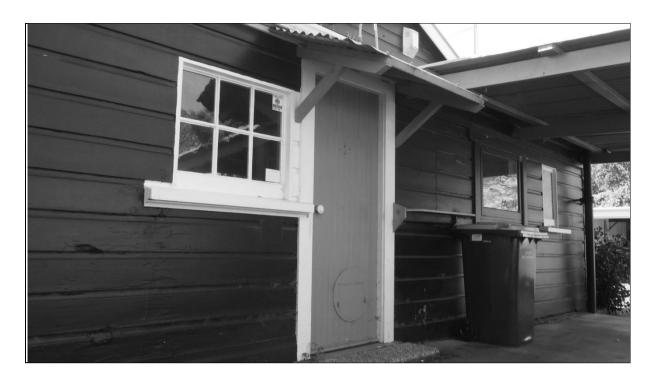
Figure 9: Photograph of the southern (rear) elevation. Much of the lean to structure is a result of later additions to the original house and is composed of materials recycled from the original rear structure or other 19th Century structures. Note the 6 pane window (usually hung vertically) does not fit the sill. Image: Ivan Bruce, 2017.

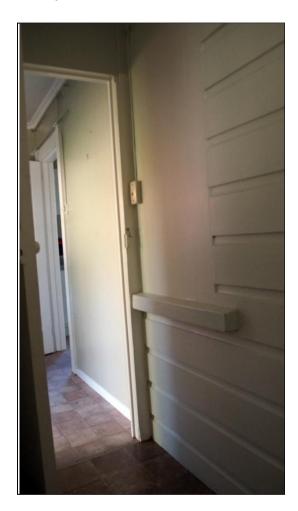
weatherboards above and below the roof. As a result the weatherboards on the western wall do not align with the southern wall. The eastern end of the lean to appears to be largely original, as evidenced by an original window and architraves on the eastern elevation and a sarking ceiling. Based on the building evidence it seems likely that there was a small structure at the eastern end of the building enclosing the entrance and a roofed veranda extended along the western wall. The enclosed lean to at the rear of 19th Century buildings usually contained the wash house and coal store. Image: Ivan Bruce, 2017.

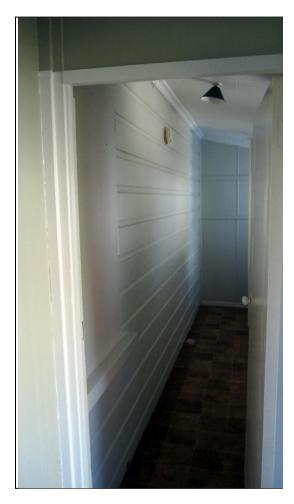
Figures 11 and 12: Interior of the rear lean to western side of the rear door. Note rusticated exterior weatherboards on the interior wall of the addition and the sill from a sash window (since covered over when the bathroom was moved inside), indicating that this was formerly the exterior rear wall of the building, most likely covered by a rear veranda. Images: Ivan Bruce, 2017.

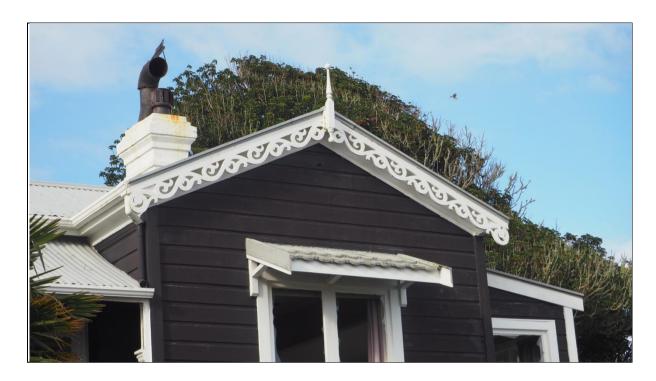
Figure 13: One of the more striking features of the building exterior was the decorative bargeboards on the northern western gables. These were absent from the rear gables where they were not required - as they couldn't be seen from the street. Image: Ivan Bruce, 2017.

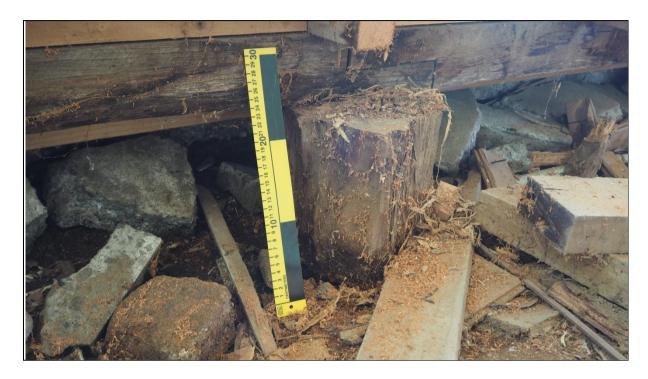
Figure 19: Totara pile below the eastern wall of the cottage. Note the bearer is lapped and joined at the pile. Image: Ivan Bruce, 2017.

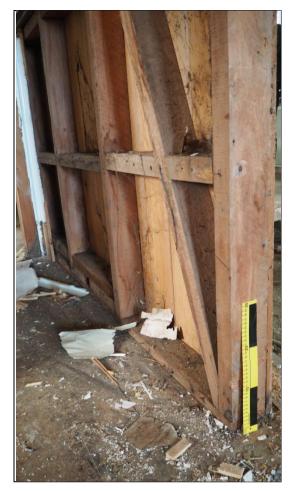
7.4 The above floor construction, when exposed by demolition, consisted of an exterior walls comprising floor to ceiling studs, approximately 400mm apart, joined by dwangs every 600mm above the floor level. An angle brace was installed on corners. The building exterior was clad with rusticated matai and rimu weatherboards and roofed with corrugated iron. Internal walls followed the same construction as described above. Neither the exterior or interior dividing walls contained insulation. The interior wall of the bedrooms and the hall way were lined with rimu or matai sarking and covered with scrim and wall paper. The lowered portion of the hallway was covered by a dado made from vertical tongue and groove boards.

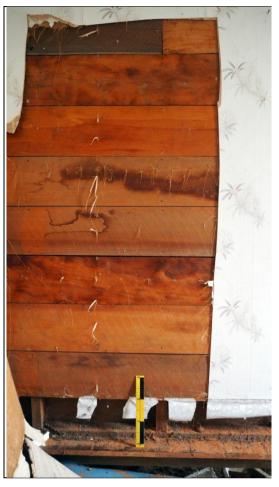
Figure 22 (left): Internal hall way wall structure. Figure 23 (right): Bedroom wall linings of rimu or matai sarking covered with scrim and wall paper. Image: Ivan Bruce, 2017.

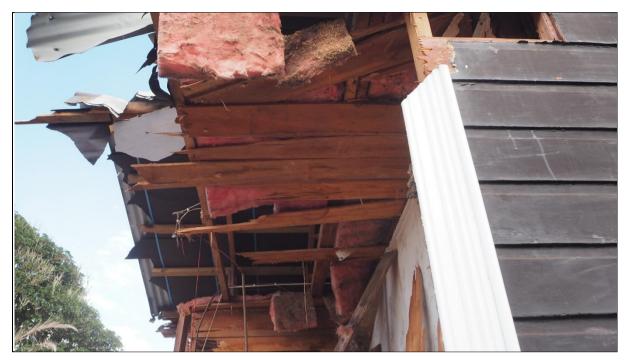
Figure 24: Undressed ceiling boards noted during demolition. Image: Ivan Bruce, 2017.

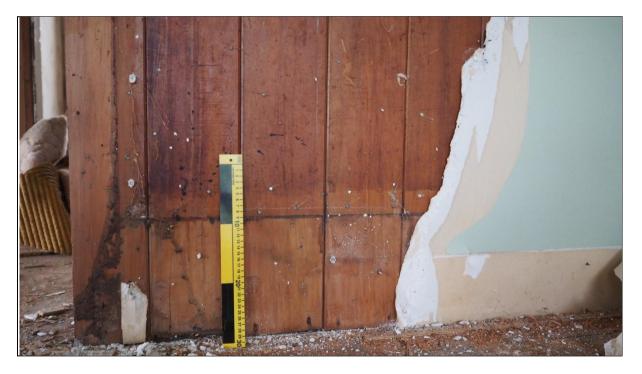
Figure 25: Varnished Tounge and Grove wall lining. Original cladding of the dining room (likely originally kitchen). Exposed beneath gib board on the eastern wall near hall doorway. Note that the original skirting boards and door architraves were removed prior to the gib board being overlaid sometime during the 1980s. Image: Ivan Bruce, 2017.

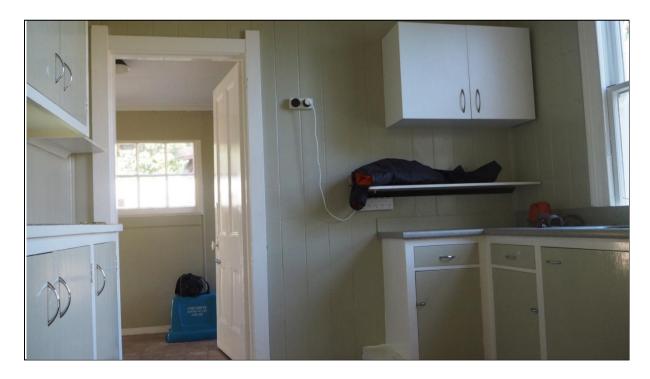
Figure 27: Southern wall of the kitchen area looking back into the lean to. Original door architraves have been replaced and all cabinetry is relatively modern. Image: Ivan Bruce, 2017.

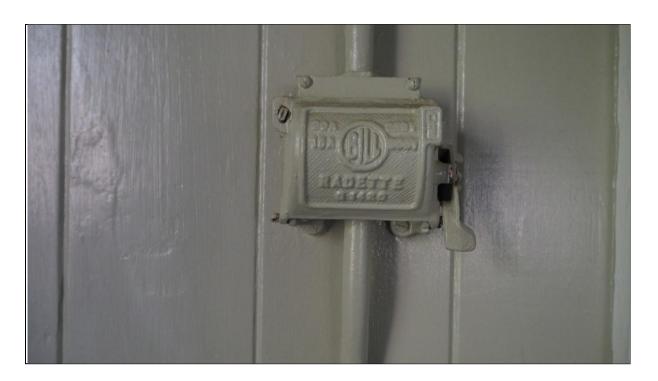
Figure 28: An early BILL switch fuse, dating sometime post 1937, on northern kitchen wall. An example of a late adaptation to electricity, as wiring had to be fixed to the outside of the wall lining. Image: Ivan Bruce, 2017.

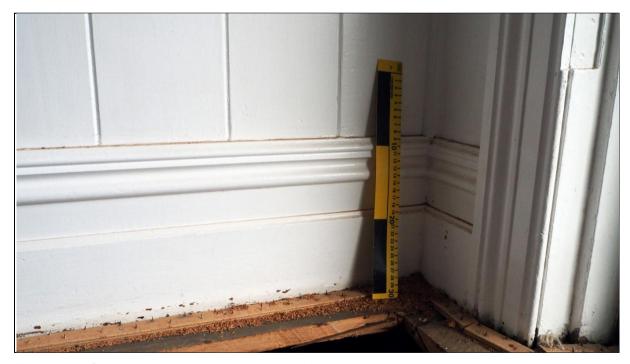
Figure 29: Original skirting boards boor architraves and hallway dado, photographed at the front door corner. These skirting boards were found in all bedrooms and throughout the hallway. Evidence was also noted in the dining room (see Figure 25). The door architraves were also noted throughout the house. Image: Ivan Bruce, 2017.

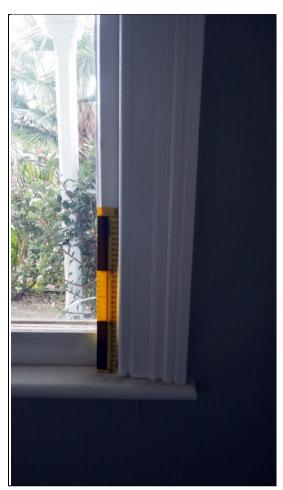
Figure 30 (left): Original hallway dado. Figure 31 (right): Original widow architraves in bedrooms, also noted in original kitchen window. Images: Ivan Bruce, 2017.

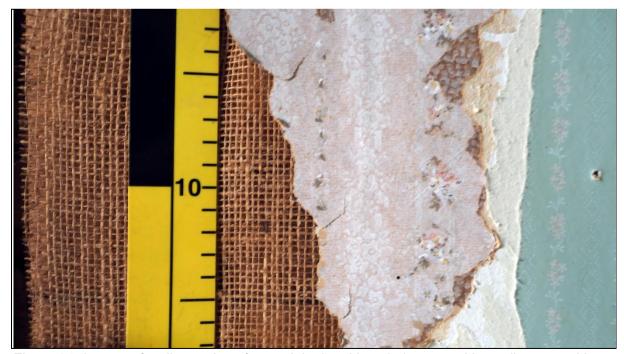
Figure 31: Layers of wall coverings from original sarking cloth covered by wall paper, with sequences of later of wall paper overlaid. Image: Ivan Bruce, 2017.

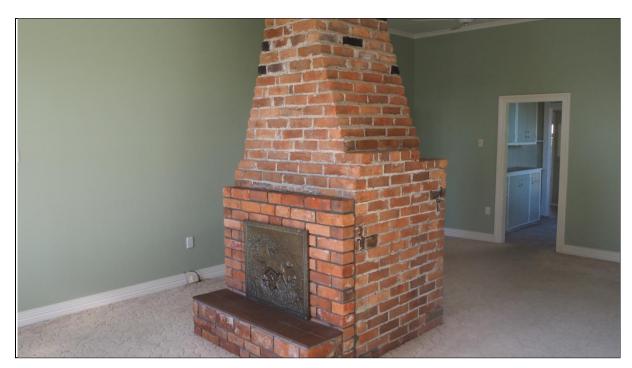
Figure 34: The double fire place. A dividing wall between what was most likely the dining room and the kitchen room had ben removed sometime prior to 1986 renovation Image: Ivan Bruce, 2017.

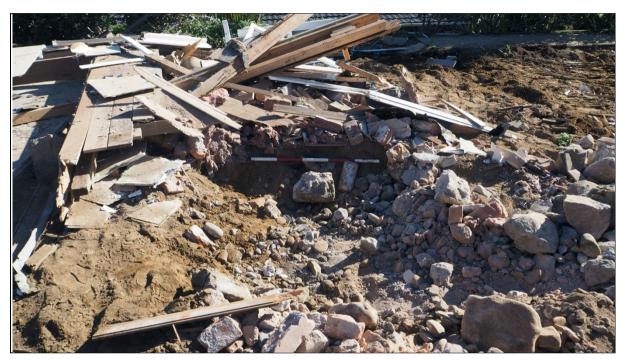
Figure 39: The fire place foundation photographed following the removal of the standing chimney, note the stone rubble and squared andesite stone blocks that were imported to the site to provide a solid foundation for the chimney Image: Ivan Bruce, 2017.

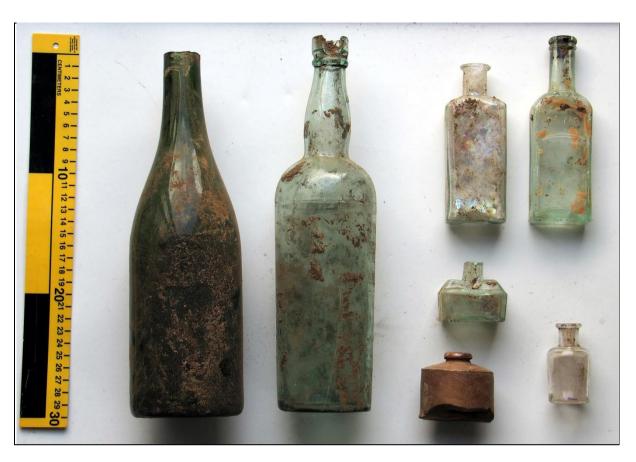
Figure 40: Late 19th Century Glass and earthenware bottles found subfloor at Small's Cottage. Image: Ivan Bruce, 2018.

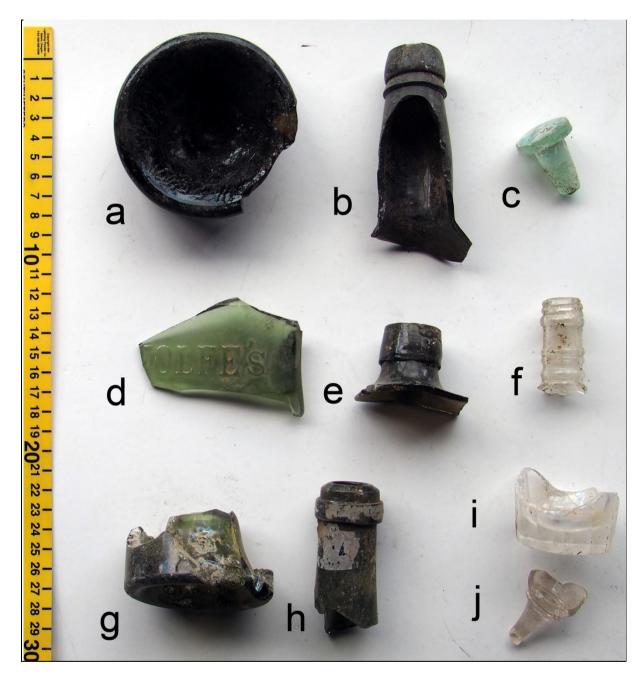
Figure 42: A range of glass artefacts recovered from the chimney base. a, black beer bottle base; b, black beer neck and top; c, glass stopper; d, Adolfe Wolfe's Aromatic Schnapps bottle fragment; e, Schnapps/ Case gin bottle top; f, Salad oil bottle top; g, Champagne/ beer bottle base; h, Champagne/ beer bottle top; i, Cut glass tumbler; j, wine glass stem. Image: Ivan Bruce, 2018.

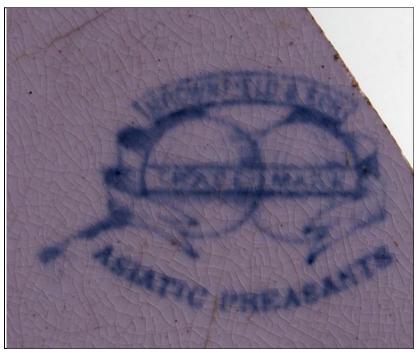
Figure 48: BROWNFIELD AND SON - TRADE MARK - ASIATIC PHEASANTS, back mark. Image: Ivan Bruce, 2018.

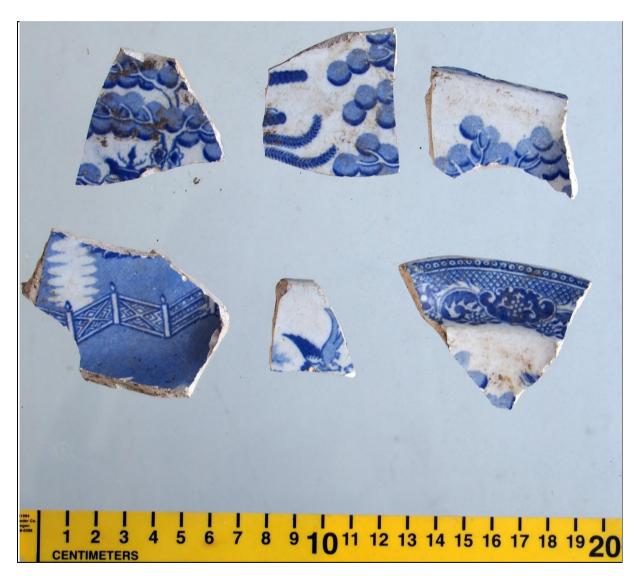
Figure 49: Fragments of WILLOW pattern plate recovered from the chimney base of Small's Cottage. Image: Ivan Bruce, 2018.
