Building/Site Name Retaining Wall and Wrought Iron Fence

Address 11 Vivian Street, New Plymouth

## **Statement of Significance**

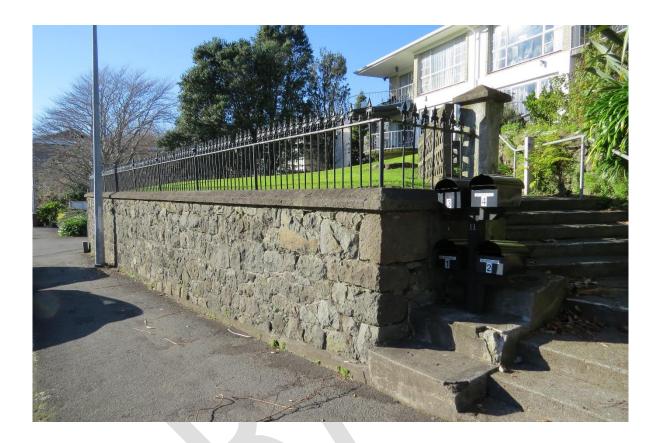
This retaining wall at 11 Vivian Street is principally constructed from stacked cut and rubble local Taranaki andesite, possibly obtained from nearby sources such as the Huatoki Stream or beachfront. Extending across much of the street frontage, the wall also extends a short distance towards the southeast at either end.

The entire wall is capped with a moulded cement coping, atop which is a wrought iron fence principally composed of vertical spindles through a single flat bar, with each spindle capped with a simple moulded fleur-de-lis. Extending a short distance towards the south-east, the wall terminates at a chamfered and capped concrete pilaster. Whilst in reasonable condition, several fleurs-de-lis have been lost.

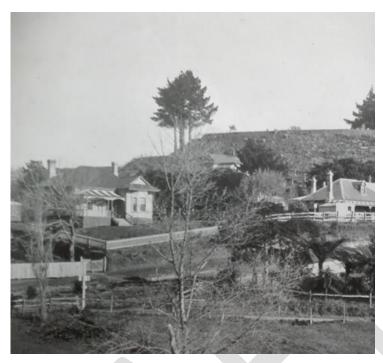
Detail from circa early-1898 view of Vivian Street looking south-east towards Marsland Hill, by George Herbert White. House still in single storey form and stone retaining wall yet to be constructed. Puke Ariki Collection, A.3.24

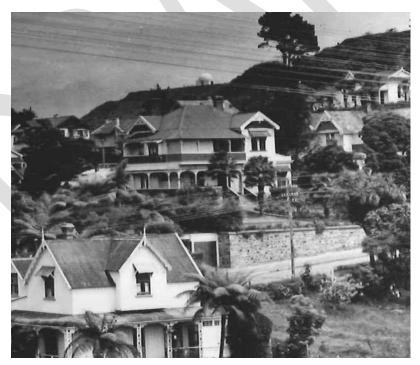
Lower Carrington Street and Vivian Street from Powderham Street, New Plymouth, John Reginald Wall, circa 1930s. Puke Ariki Collection, PHO2015-0102
