Honeyfield Fountain, New Plymouth

# CONDITION AND REMEDIAL ACTION REPORT

*Ian Bowman, Architect and conservator*  
2003

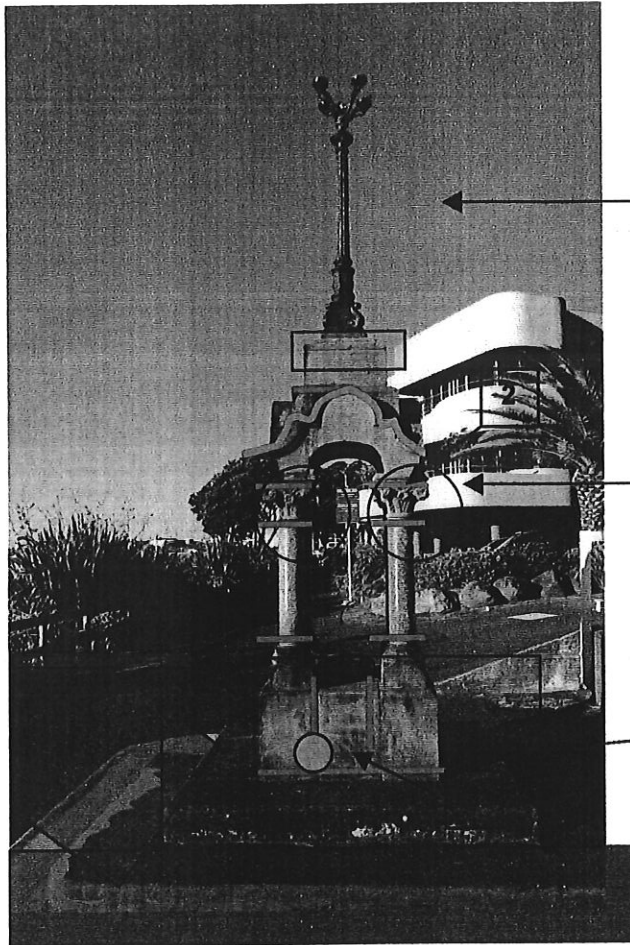
**WEST ELEVATION**

Rusting, damaged  
lamp standard with  
missing fittings

Missing volute details  
Alveolisation of capitals  
and interior
